WT-1323

Operation **REDWING**

Project 2.9

STANDARD RECOVERY PROCEDURE FOR
TACTICAL DECONTAMINATION OF SHIPS

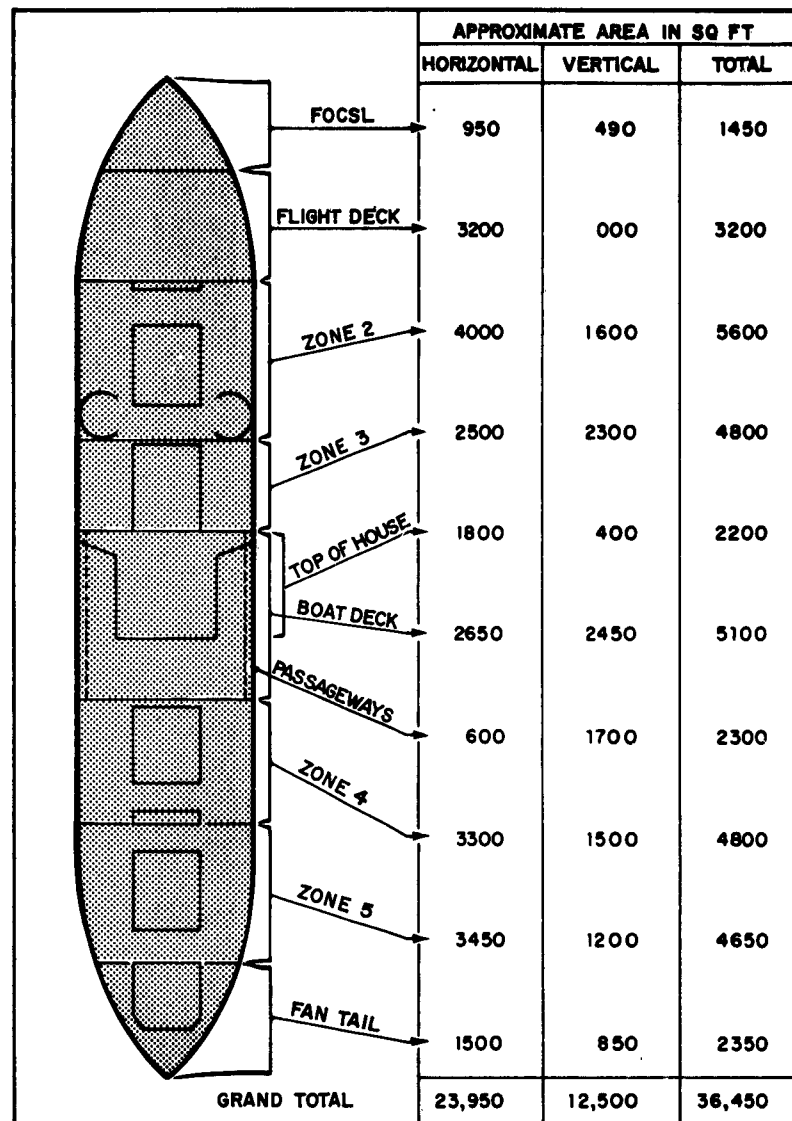
Figure 2.1 Zoning and area of weather surfaces of YAG-39 and YAG-40.

The YAG-39, YAG-40, and LST-611, each equipped with a washdown system, participated in Shots Cherokee, Zuni, Flathead, Navajo, and Tewa. In each of the above shots, these ships were positioned in the predicted area of fallout and served as fallout-collection stations for Project 2.63. On both the YAG-39 and YAG-40, the main weather deck forward of the superstructure was deprived of washdown so that the fallout could be sampled and other desired radiation information obtained. Further division of the ships into specific zones and areas is shown in Figure 2.1.

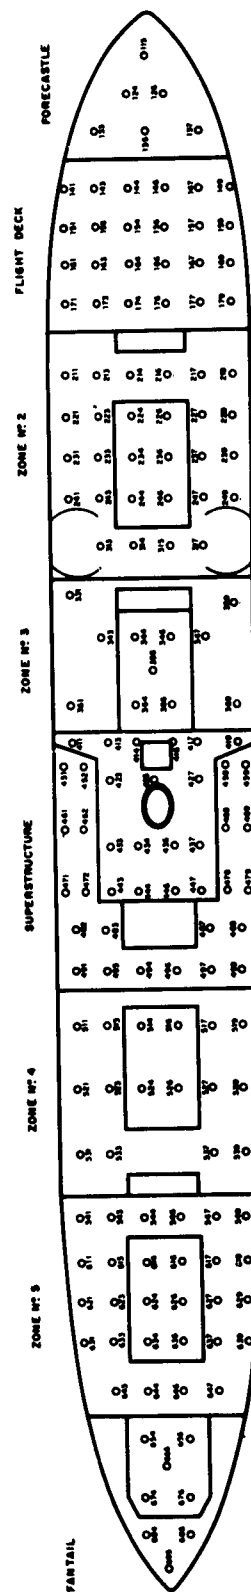
Figure 2.5 Location of 160 permanent radiological survey stations, YAG-39 and YAG-40.

2.3.1 Gamma Measurements. Readings were taken before and after decontamination at predetermined weather-deck stations on each ship. There were 174 stations on the YAG-39, 174 on the YAG-40, and 24 on the LST-611. The locations of 160 of these stations as used by Project 2.9 on the YAG's 39 and 40 are shown in Figure 2.5. Measurements were made over each station at 1 inch and 3 feet.

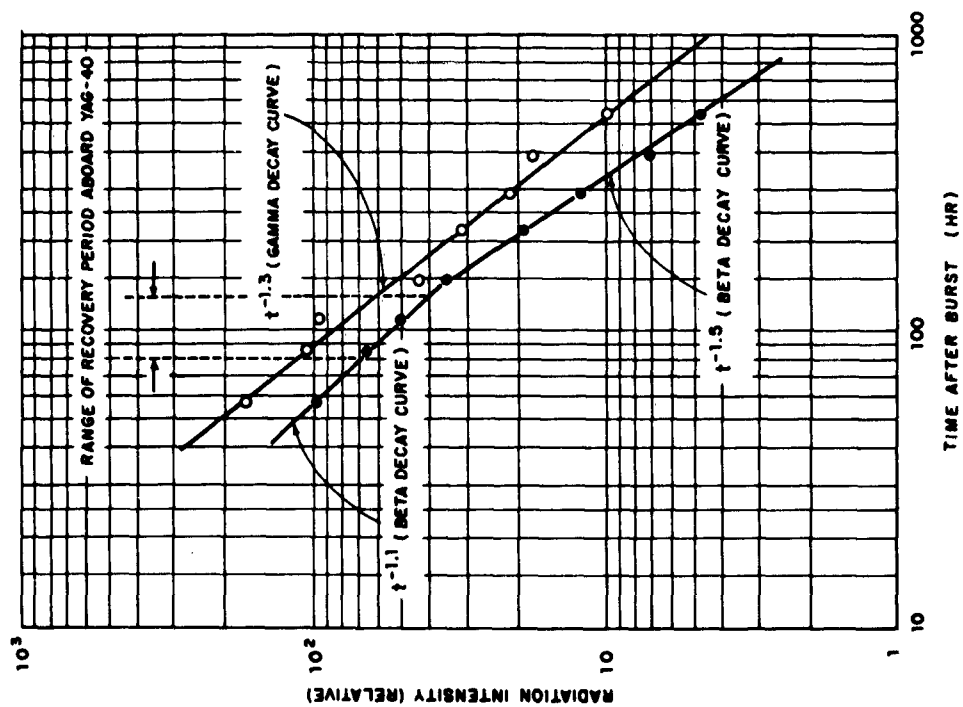
Figure 2.6 Decay curves from YAG-40 test panel, Shot Zuni, as determined by AN/PDR-T1B and RBI-13.

the time interval covering the period of ship recovery. The resultant decay curves appear in Figures 2.6 and 2.7.

Over periods of several days, radioactive decay of undisturbed contaminant obeys a t^{-n} relation, where t is the time after detonation and n is a constant decay exponent. The decay curves of Figures 2.6 and 2.7 are typical examples of this relation. However, during recovery operations the decay rate may be altered due to fractionation of the contaminant. Because there is no convenient way to readily determine the degree of fractionation, a normal (t^{-n}) decay must be assumed and the available curves used.

The decay exponents for Shots Zuni and Tewa, as determined from Figures 2.6 and 2.7, are given in Table 2.1. For Flathead and Navajo, approximate values of n based on information furnished by Project 2.63 are also tabulated.

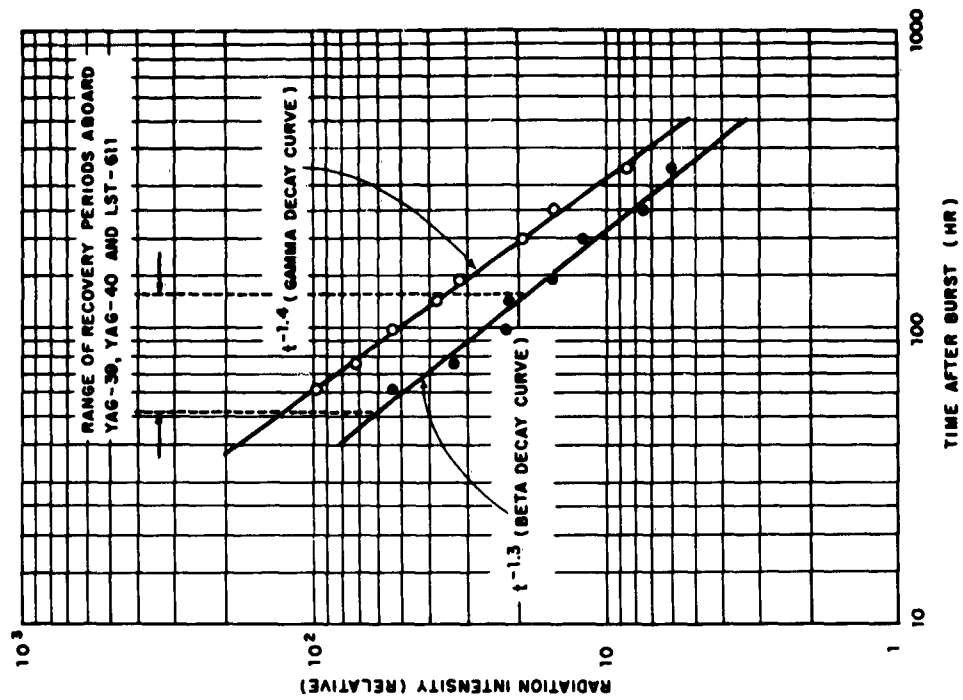
Figure 2.7 Decay curves from YAG-39 test panel, Shot Tewa, as determined by AN/PDR-T1B and RBI-13.

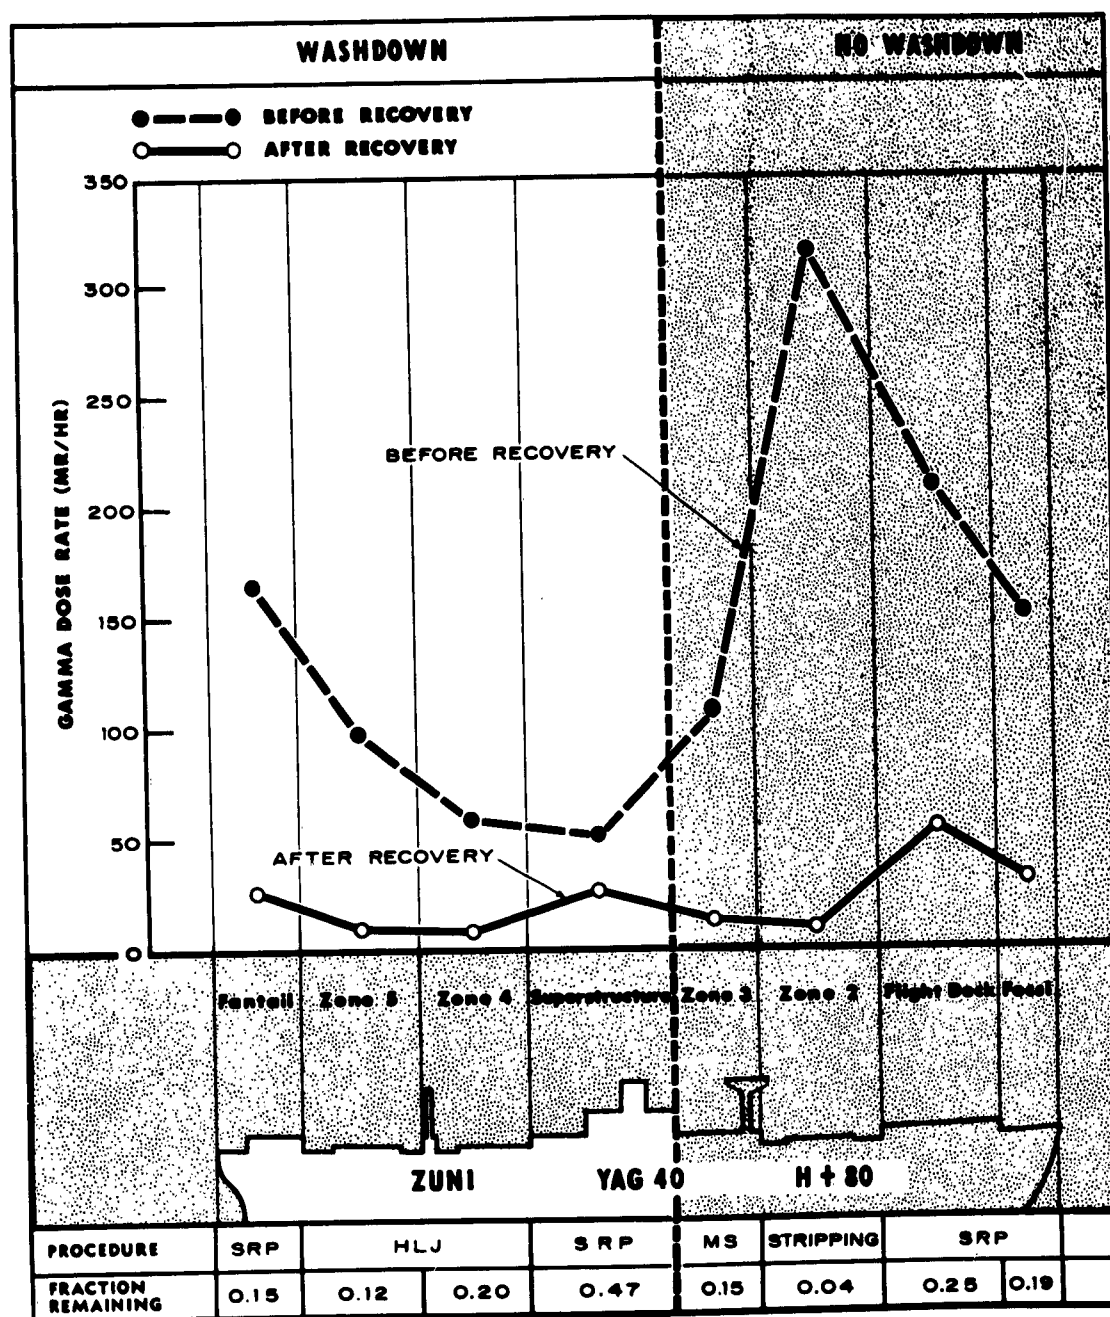
Figure 3.1 Average gamma dose rate in the test areas, Shot Zuni, YAG-40.

3.1.2 Shot Zuni. On YAG-40 at the beginning of decontamination, H + 80 hours, the points in Figure 3.1 show that the average initial dose rates ranged from 50 mr/hr on the washdown area to 320 mr/hr in the nonwashdown area. With the exception of the flight deck, decontamination reduced each of these average levels to less than 30 mr/hr. Although the average final level on the flight deck remained at 55 mr/hr, this represented a 75-percent reduction from the initial level.

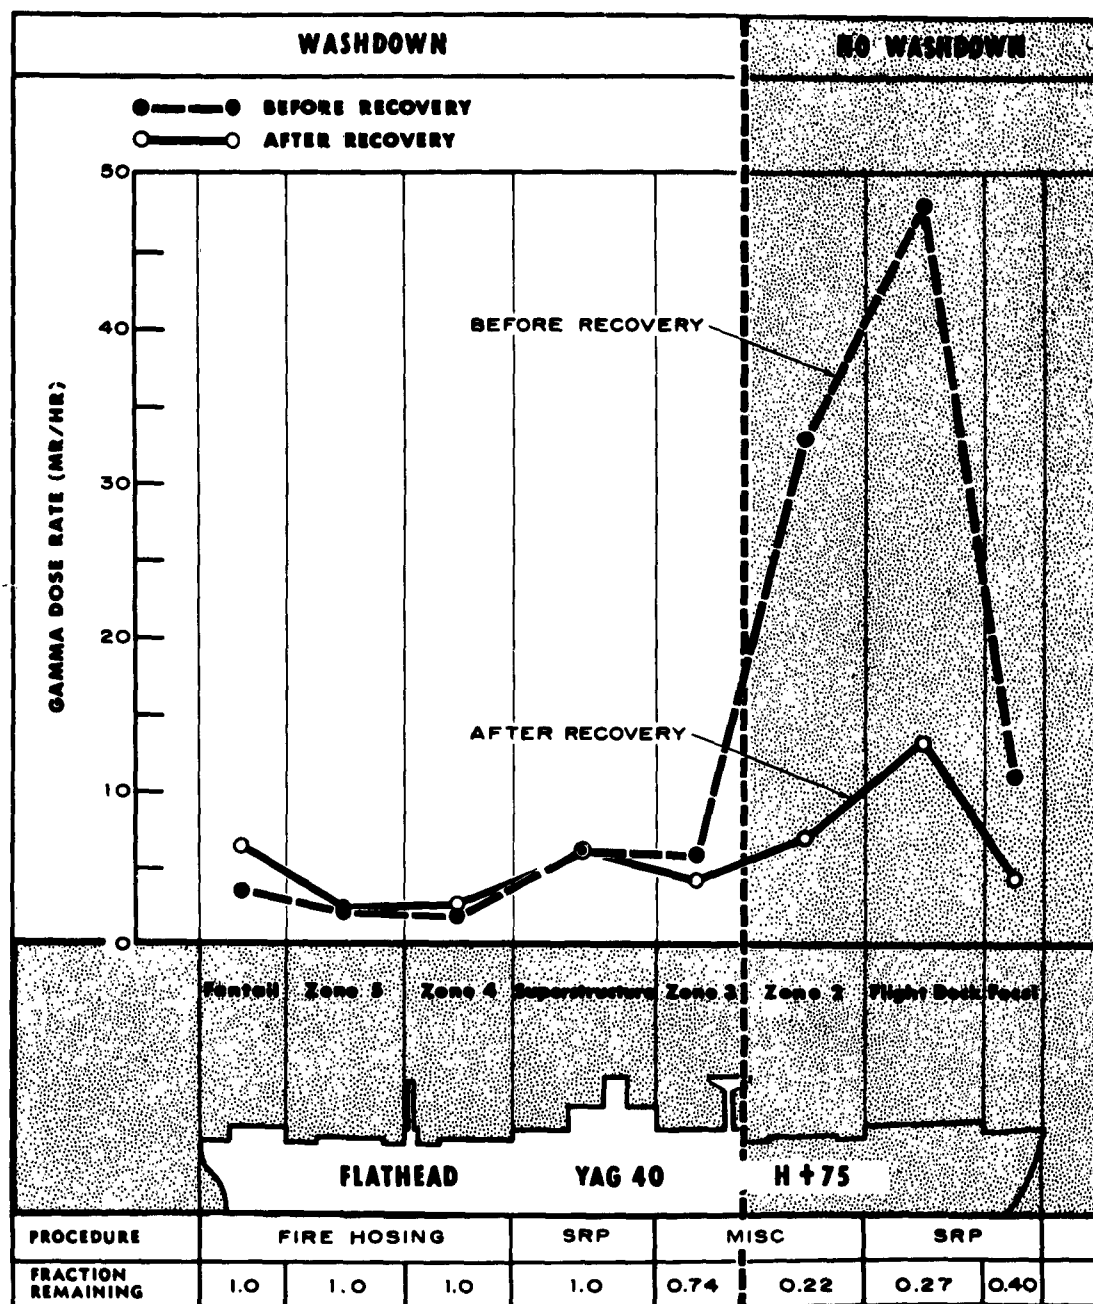
Figure 3.2 Average gamma dose rate in the test areas, Shot Flathead, YAG-40.

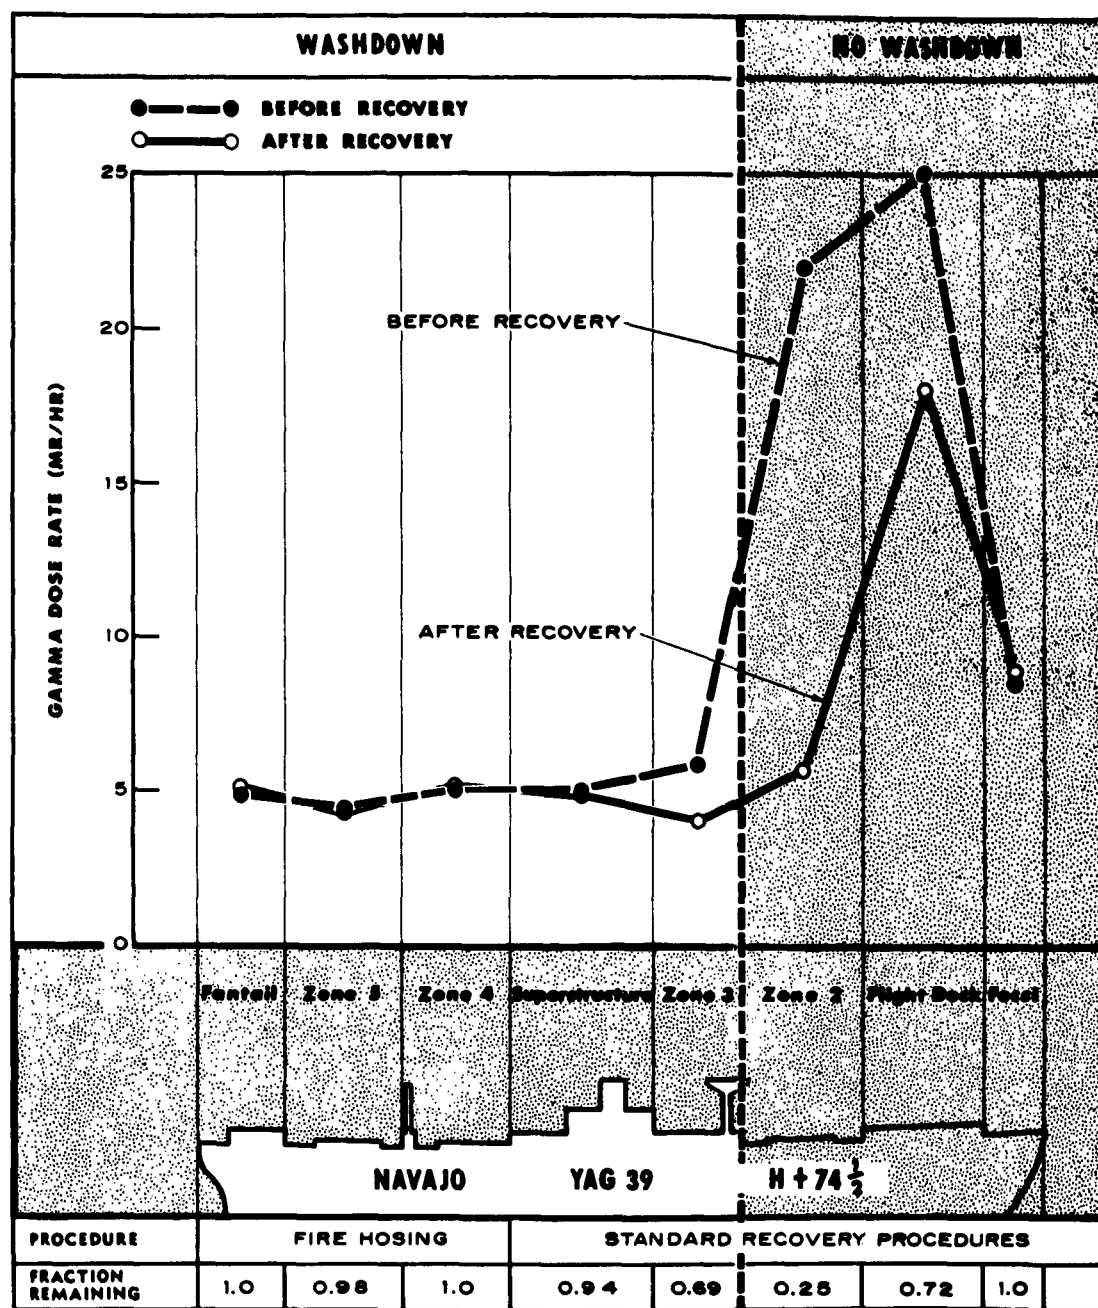
Figure 3.3 Average gamma dose rate in the test areas, Shot Navajo, YAG-39.

The results of decontamination on the nonwashdown region of YAG-39 are indicated in Figure 3.3. Zone 2 was the only test area that exhibited a marked reduction in average

dose rate, 75 percent. The flight deck, which was beginning to show the effects of weathering, was reduced from 25 mr/hr to 18 mr/hr, a reduction of 28 percent. The forecastle, together with the washdown section aft, showed little or no reduction because of the extremely small initial radiation levels.

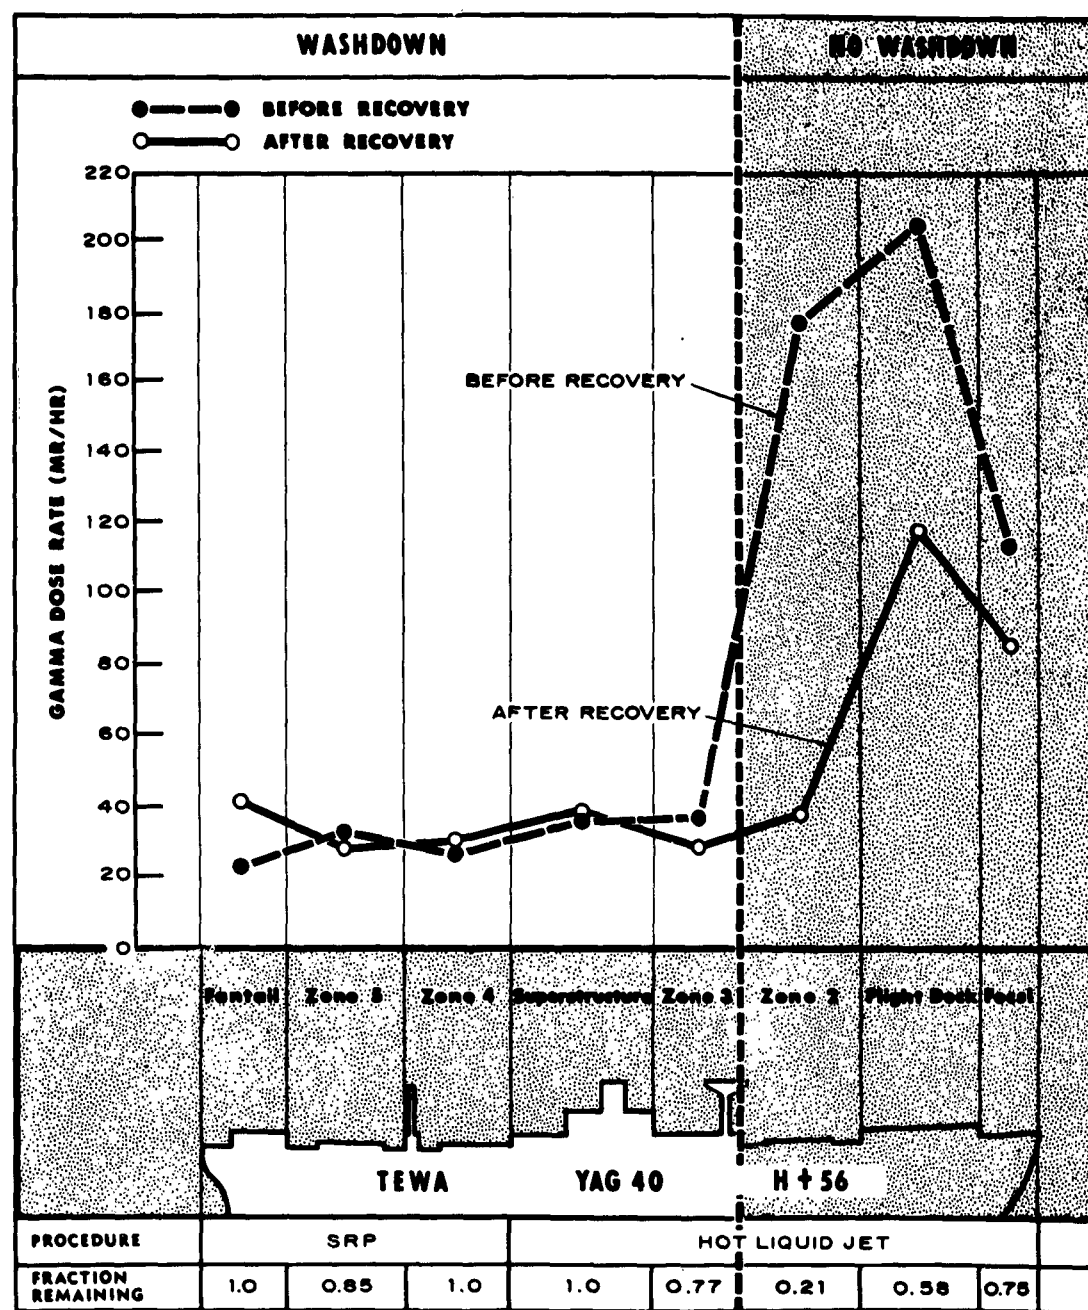
Figure 3.4 Average gamma dose rate in the test areas, Shot Tewa, YAG-40.

The operational decontamination of YAG-40 (Figure 3.4) reduced the dose rates in the nonwashdown region over a range varying from 25 percent in the forecastle to 79 percent in Zone 2. The ineffectiveness of decontamination was largely due to the cramped, complex configuration of the forecastle and the exposure of bare wood planking on the flight deck. The poor surface condition of the flight deck resulted from weathering, previous recovery operations, and abrasion from daily traffic.

Again, this difference in effectiveness aboard the two ships may be related to the increased recovery effort expended aboard YAG-39 and the greater success of the washdown system aboard YAG-40. A minimum beta-dose-rate condition existed which parallels that discussed in Section 4.1.3 with respect to the gamma levels of Figures 3.4 and 3.5.

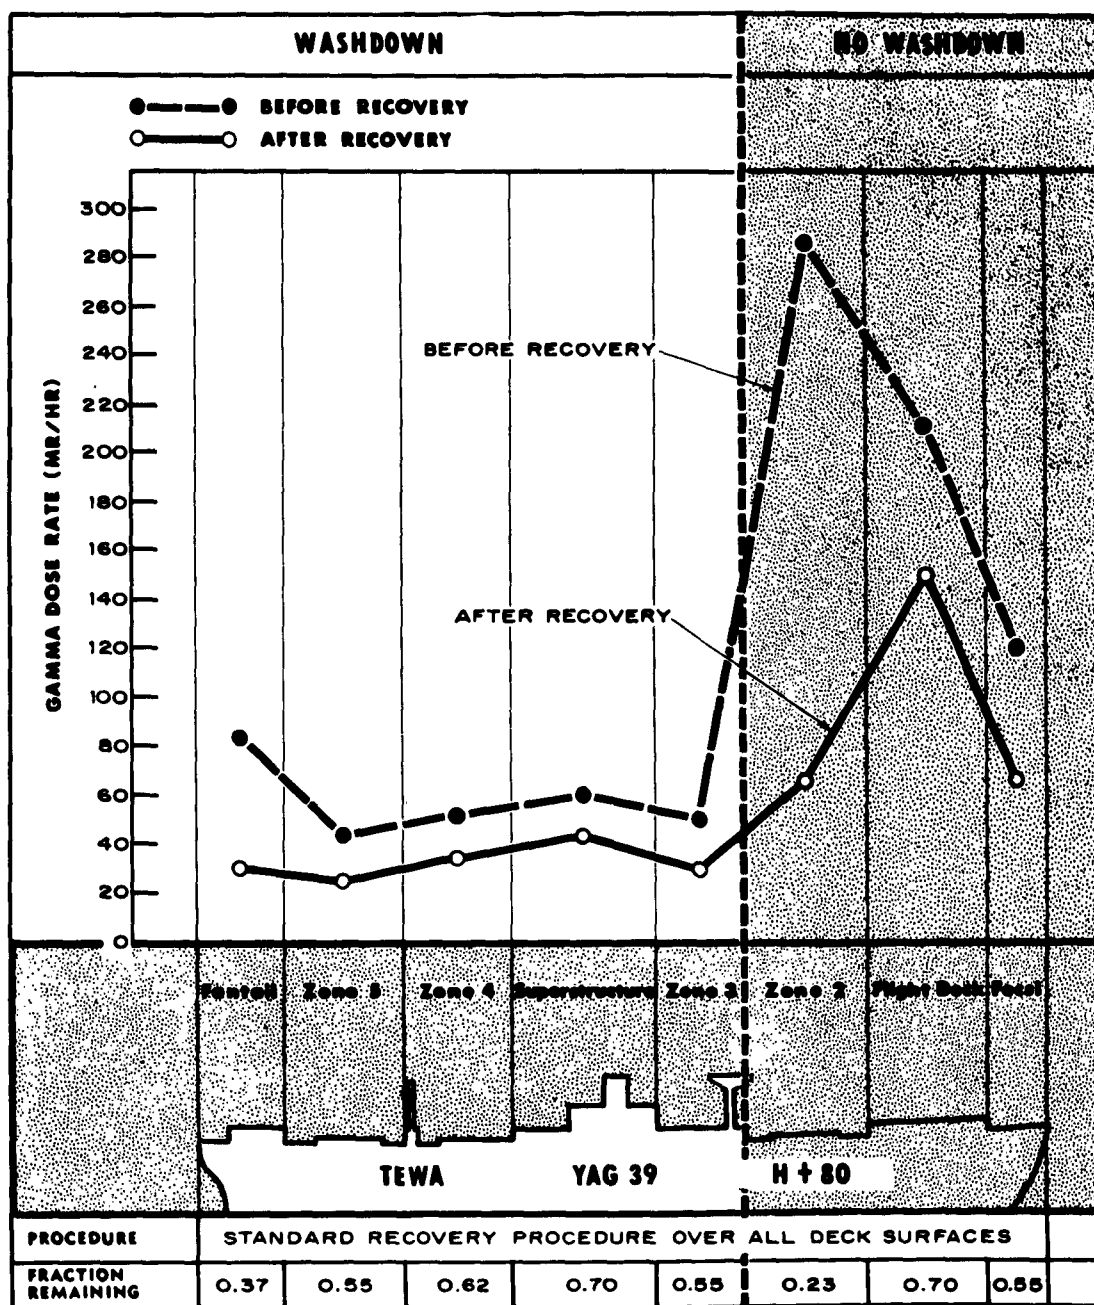
Figure 3.5 Average gamma dose rate in the test areas, Shot Tewa, YAG-39.

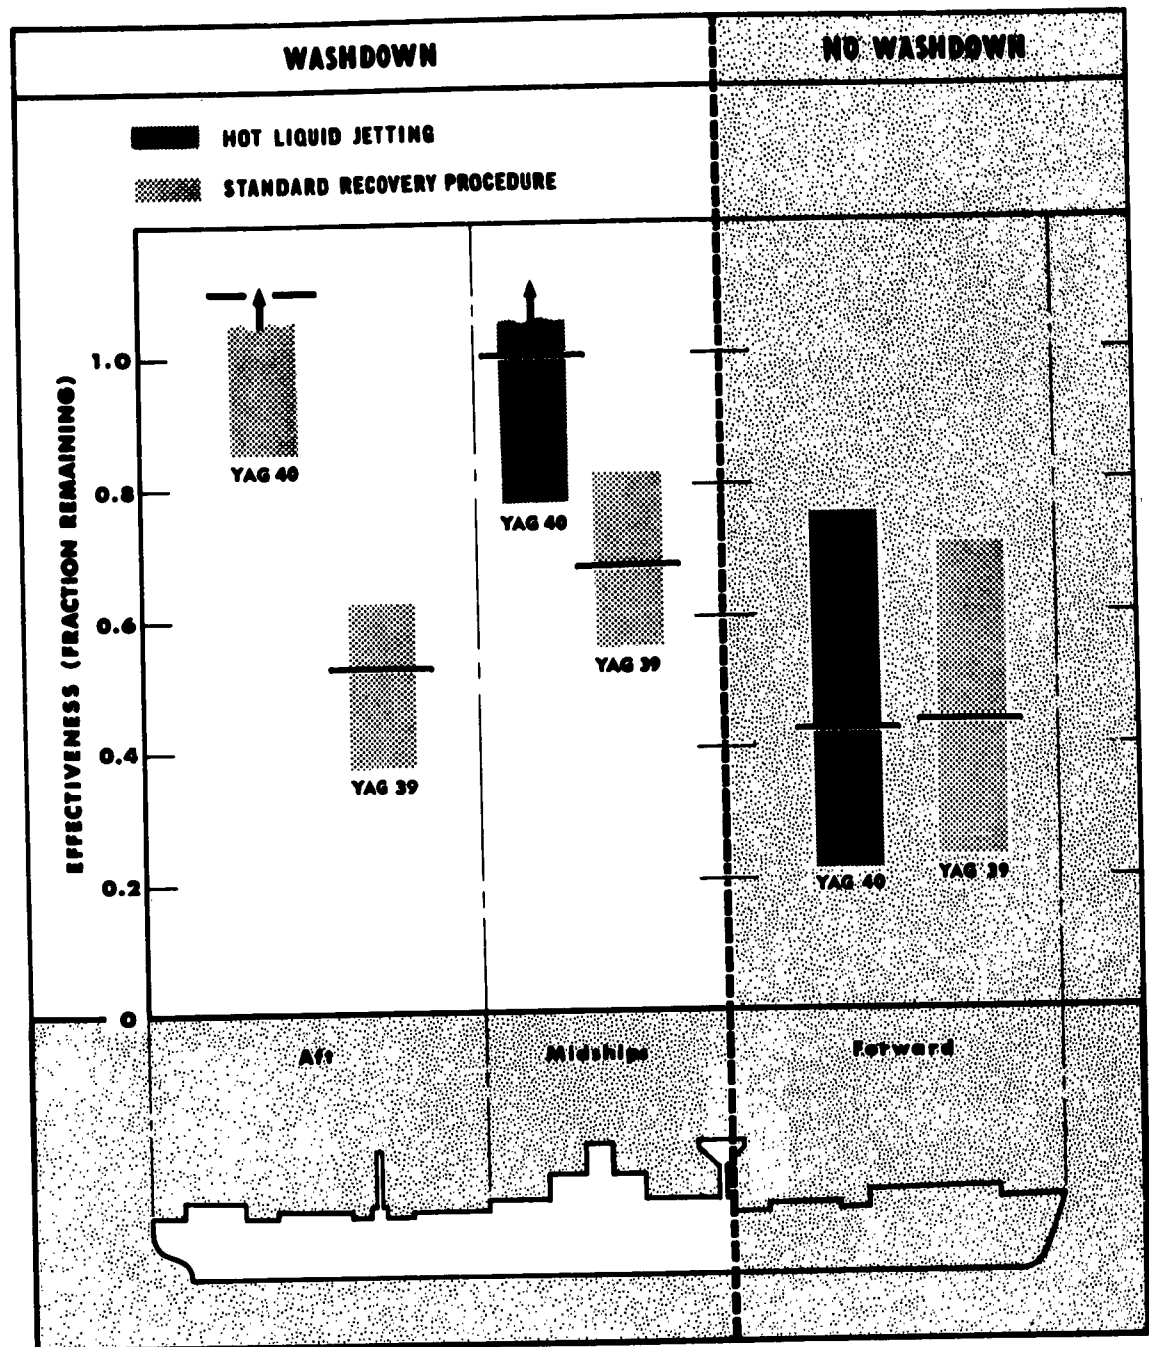
Figure 4.1 Recovery effectiveness, gamma, Shot Tewa.

The influence of deck surface condition and configuration is reflected in the wide ranges which the two bars cover. The more-weathered or complicated surfaces of the flight deck and forecastle give larger fractions remaining, 0.55 and greater, in the upper half

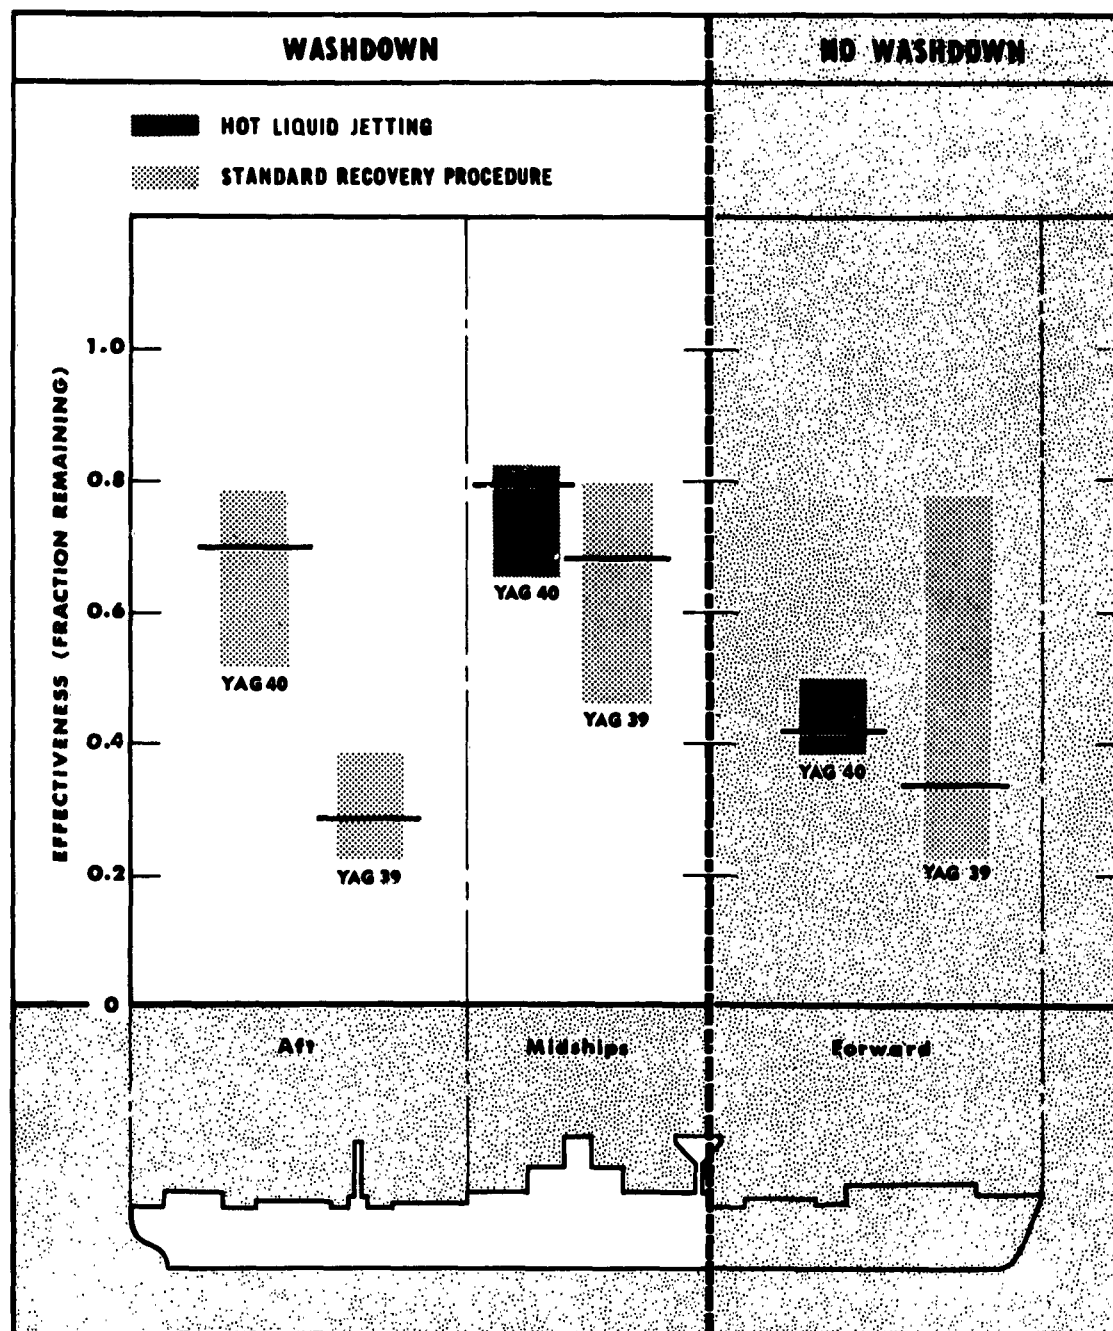
Figure 4.2 Recovery effectiveness, beta, Shot Tewa.

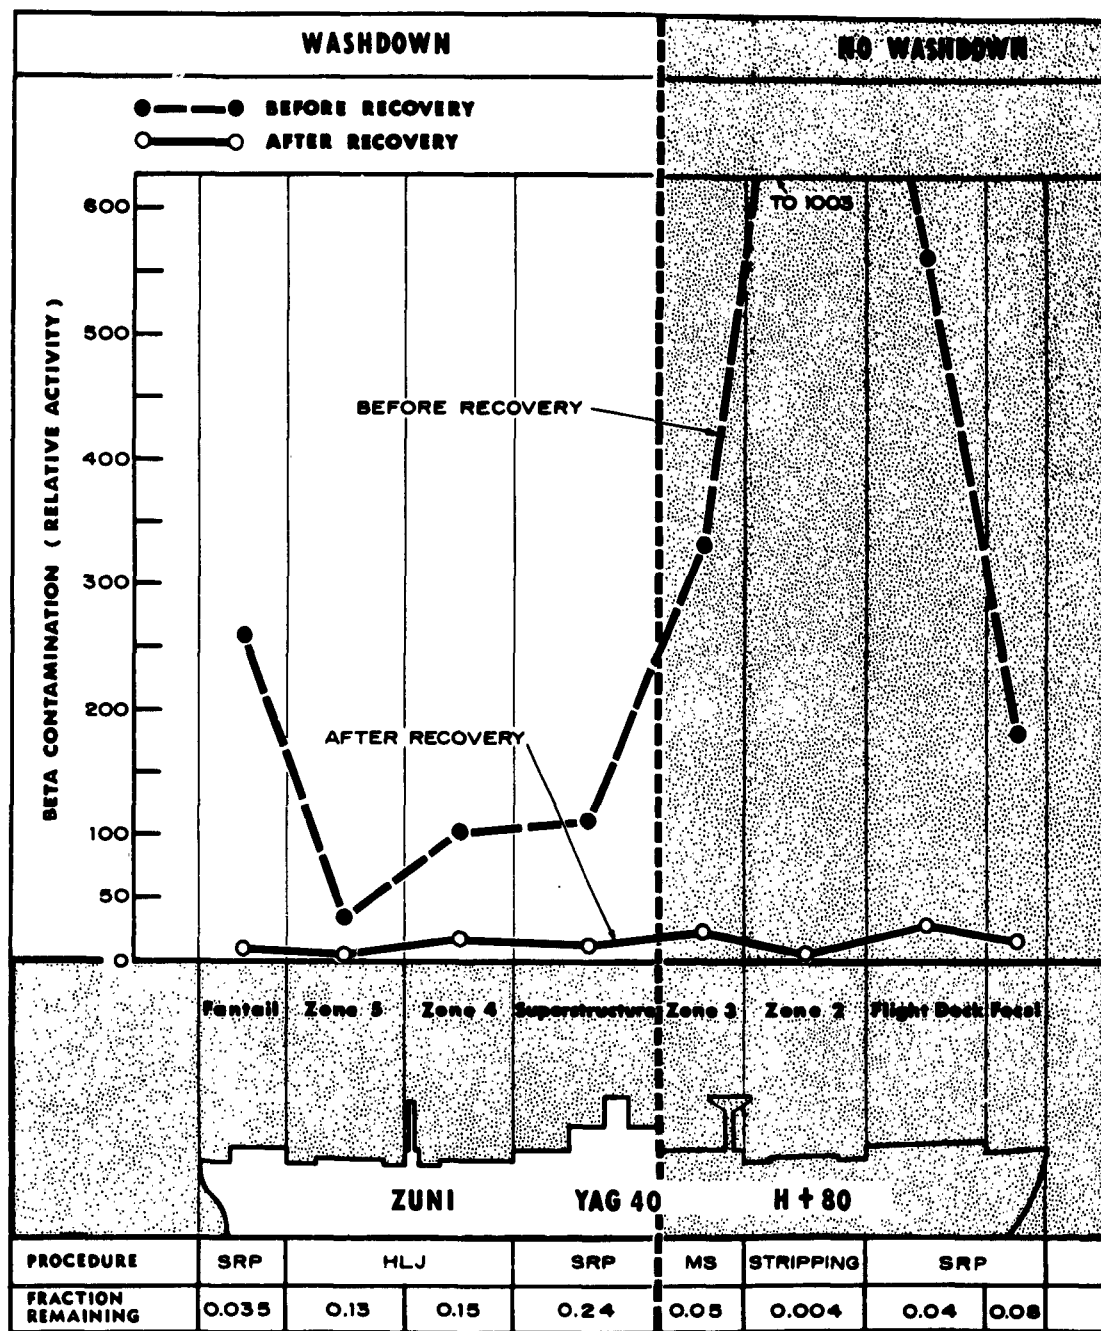
Figure B.1 Average beta contamination level in the test areas, Shot Zuni, YAG-40.

2.3.2 Beta Measurements. Beta readings were taken on the surface at each station. These data are presented in the beta dose-rate charts contained in Appendix B.

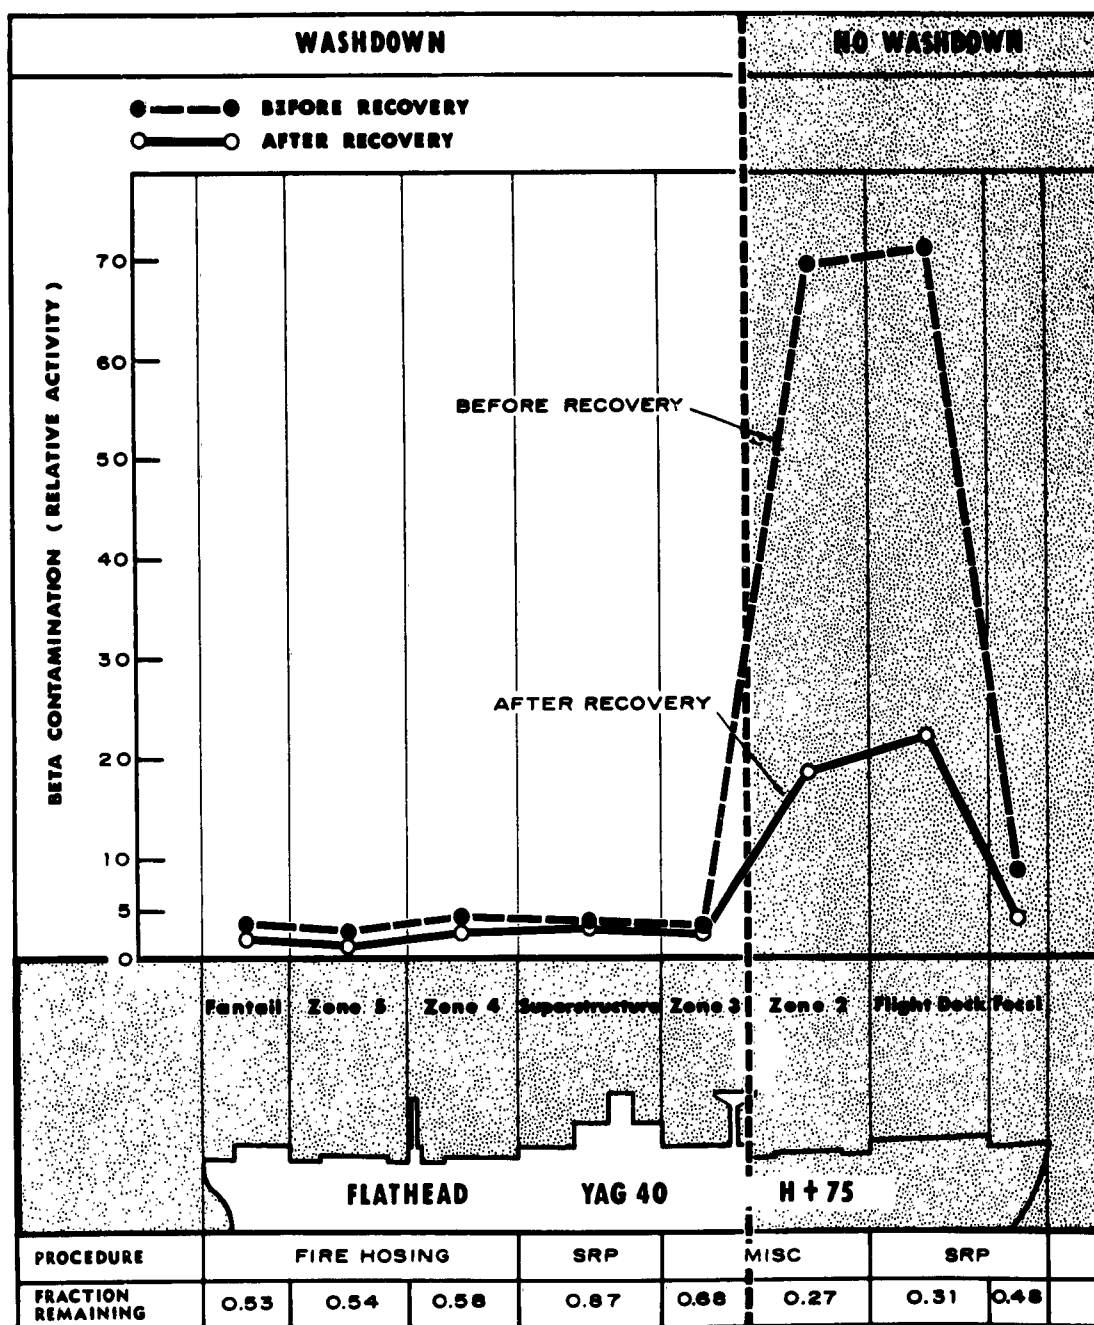
Figure B.2 Average beta contamination level in the test areas,
Shot Flathead, YAG-40.

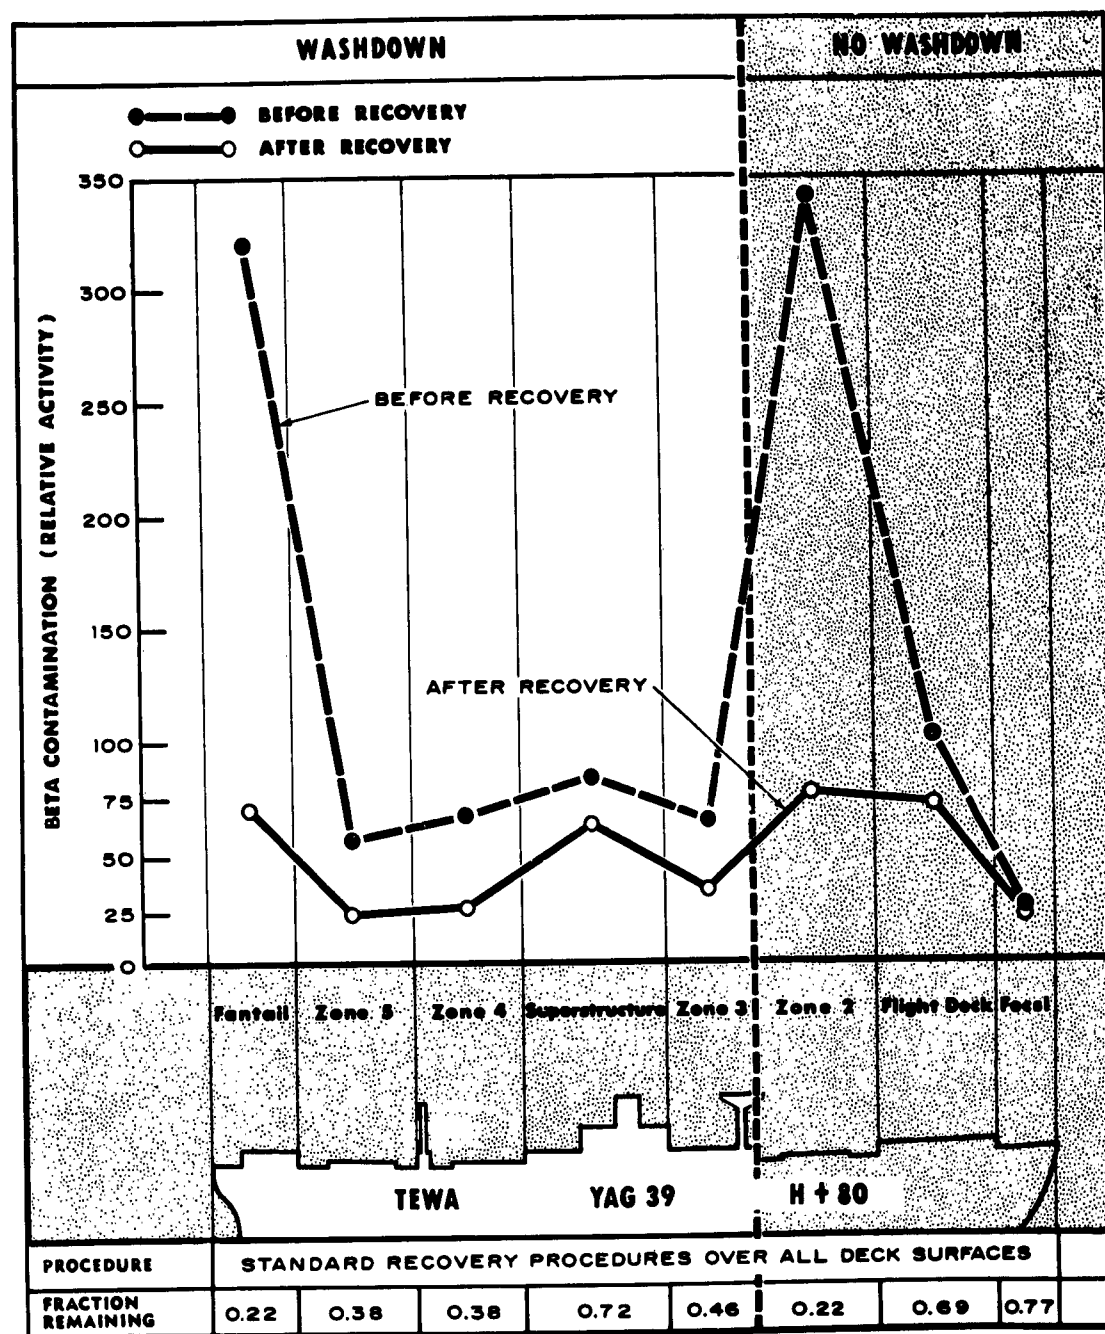
Figure B.3 Average beta contamination level in the test areas,
Shot Tewa, YAG-39.

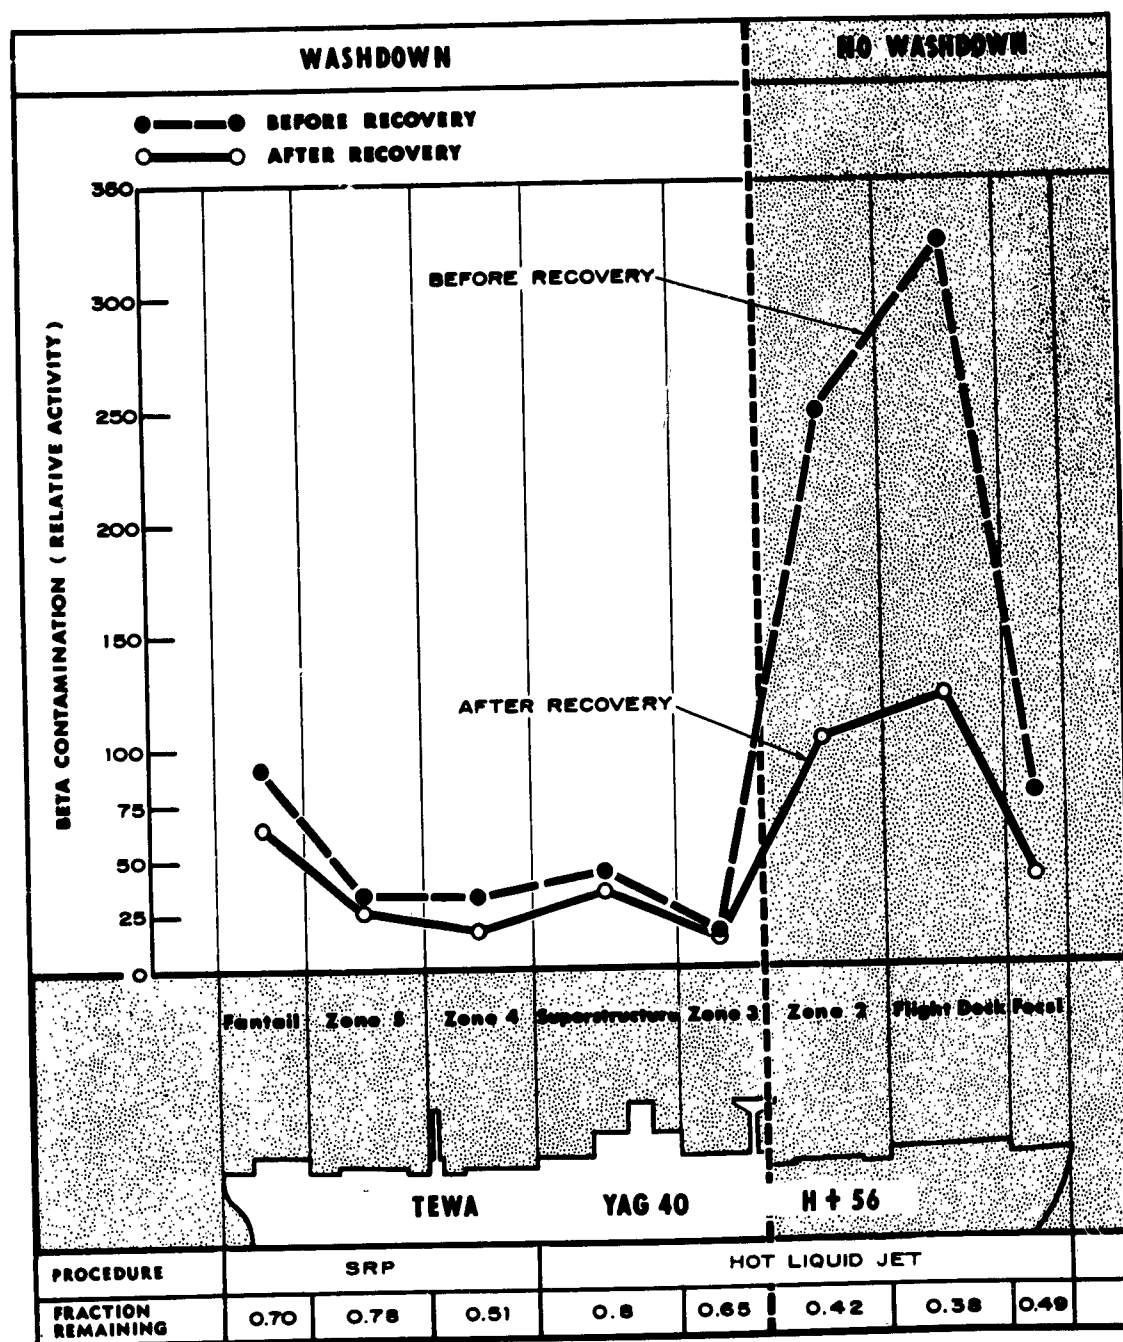
Figure B.4 Average beta contamination level in the test areas, Shot Tewa, YAG-40.
